# Manhole Inspection Summary

Manhole # S37E\_\_056MH

Insp Date: **10/20/08 2:44 PM**

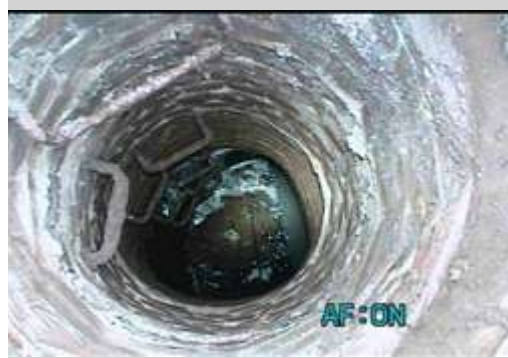
Top View

channel to the side

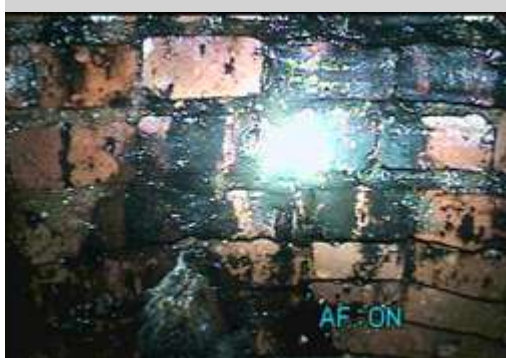
Defect 4

Infiltration: ☐ None ☐ Joint ☐ Cracks ☐ Mortar ☐ Roots ☒ **Wall**

infiltration

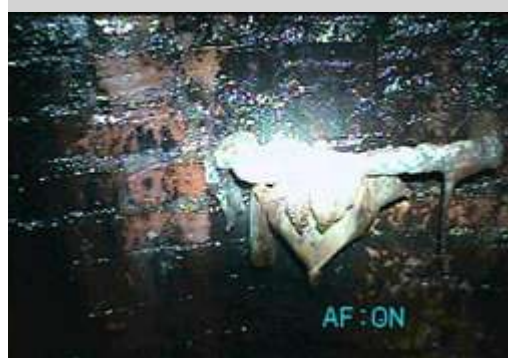
Defect 3

☒ **Evidence Of Surcharge** Depth: **4.** (ft.) ☐ Active Surcharge Present

surcharge evd

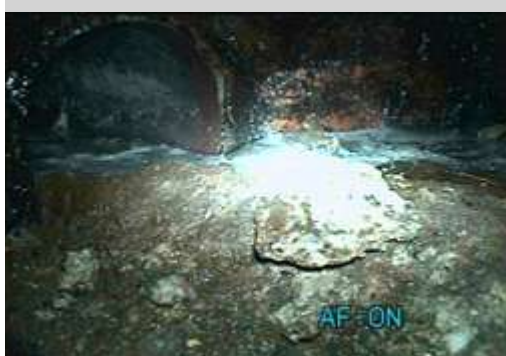
Defect 2

Condition: ☐ Sound ☐ Cracked ☐ Root Intrusion ☐ Deteriorated ☐ Leaks ☒ **Debris**

bench debris

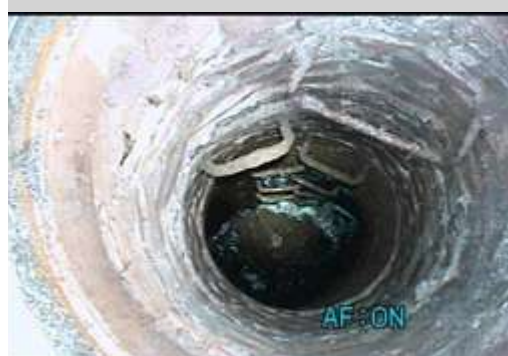
Defect 1

Count: **9** Missing: **0** ☒ **Corroded**

corr steps
